Consulting Arborist and Horticulturist  
**Root & Bough**  
ENTERPRISES, INC.

August 22, 2026

At your request on August 14, 2026, the following is an arborist report for trees at the Coalinga Branch and the Huron Branch of the Library District. This report includes the survey method, location, species, condition, observations, discussion, conclusions, and tree recommendations. The client provided facts about the trees, and a walk-through and evaluation were performed on August 18, 2026.

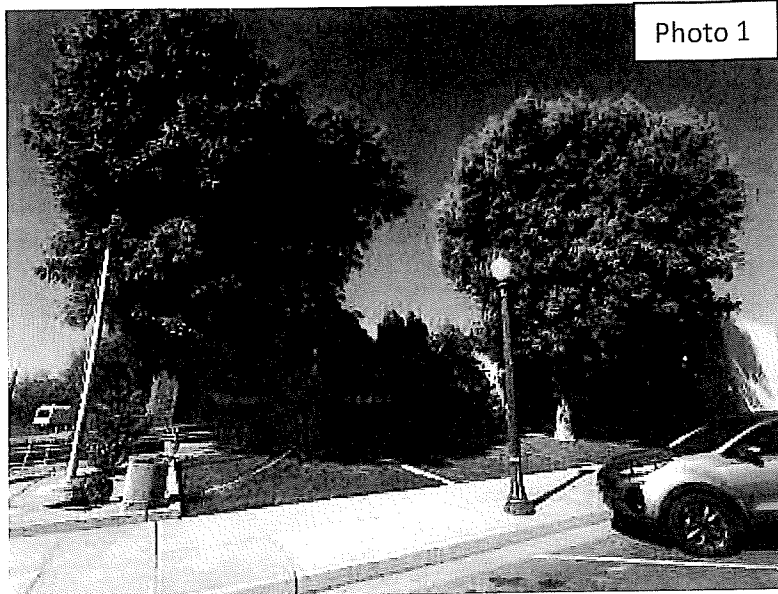
COALINGA Leaning Chinese Pistache - There were two Chinese Pistache (*Pistacia chinensis*) trees in front of the library. The tree to the northwest was in good condition and health. The tree to the southeast was leaning severely. It had a lean of approximately 33° to the southeast; see Photo 1

on Page 2. It had a diameter at breast height (DBH), measured at 4.5 feet above grade, of 26 inches. There was cracking in the soil on the side opposite the lean; see Photo 2 on Page 2. It also had a cracked buttress root and some wood decay on the side opposite the lean; see Photo 2. The northwest side of the tree near the base, opposite the lean, was indented; see Photo 2. The tree was leaning against the flagpole near the corner of Fourth and Duran; see Photo 3 on Page 3. The flagpole was a 5 1/2-inch-diameter metal pole. The flagpole was slightly leaning due to pressure from the tree.

The indentation in this tree, opposite the direction of lean, may have been due to past disease or damage, which could have weakened the root system on that side. The flagpole was likely partially supporting the tree and was leaning under the tree's pressure. If the tree were to fail, it would likely take the flagpole with it, and the flagpole and the tree would fall across the sidewalk between the tree and the library, along Duran Street, and into the parking stalls, including the handicap accessible parking stall on Duran. The targets would be the flagpole, which was also a mitigating factor unless it also fell, in which case it would increase the risk of damage to automobiles parked in the parking stalls on Duran and to any people walking around the southeast side of the tree, and if the tree rolled a little bit more to the south than the east, it could damage the library building. This tree presents a high risk to people, autos and some infrastructure.

I recommend the tree be removed and the stump ground out.

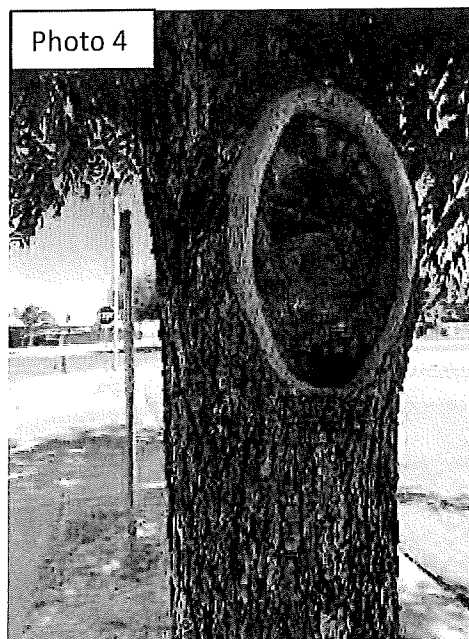
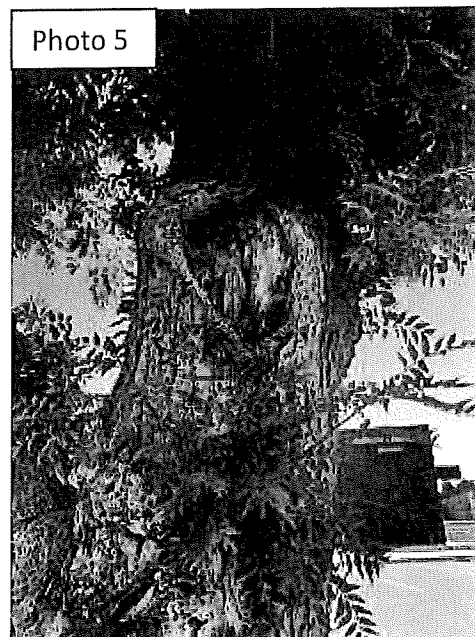
HURON Chinese Pistache - There were eight mature Chinese Pistache along 'O' Street in front of the Library. Most of the Pistache trees had some wood decay in the trunk where old branches had been cut off; see Photos 4 & 5 on Page 3. None of the Chinese Pistache along the street appeared to pose a high risk at the time of inspection. These Chinese Pistache trees should be inspected annually.

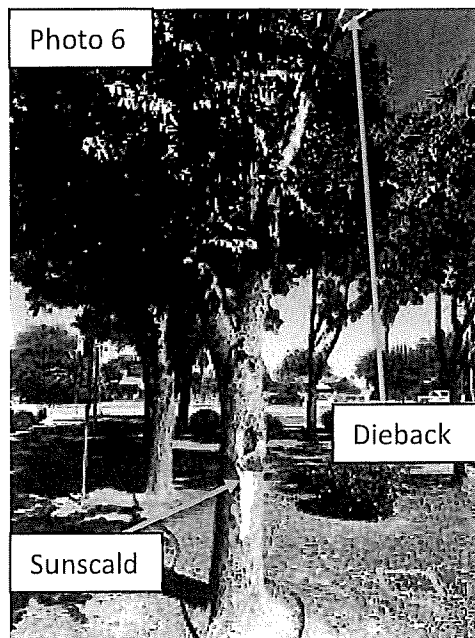
with dieback of large branches; see Photo 6 on Page 4. This tree should be removed and replaced with a better species or just removed.

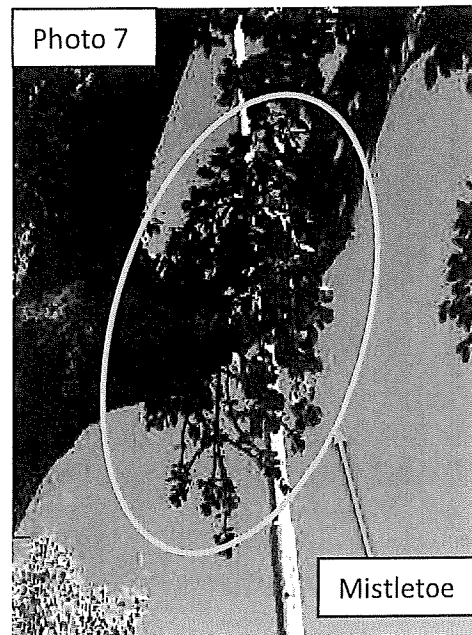
There was mistletoe growing in a few of these trees; see Photo 7 on Page 4, and it should be pruned annually.

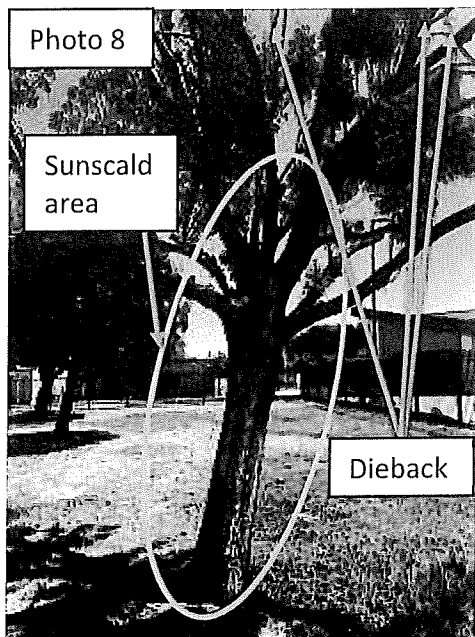
except for one. The farthest one east, closest to the school to the southeast; see Photo 8 on Page 4, leaned strongly to the east, with a large percentage of trunk damage and exposed wood facing west and southwest. The southwest-facing side received the hottest afternoon sun, a common cause of sunscauld. The bark on the trunk and some of the scaffold branches facing toward the southwest had been burned off, and the tree had damaged tissue that had wood decay in it. The tree was in very poor health and had extensive dieback on the school side. I recommend removal of this tree.

This type of tree needs a fairly high level of irrigation. They should have some sort of irrigation installed within their root zone between the trunk and the outer portion of the canopy, commonly referred to as the drip line. No water should hit the trunks at all, if possible. This will help keep

diseases from taking advantage of them. They should not be severely pruned, and the branches of the canopy should be left wide enough that the sun cannot hit the trunk of the tree for very long at any given time. If these trees are over-pruned, they cannot adapt quickly enough to the sunshine on the south, southwest, and west sides, and they will get sunscald. After the sunscald, wood decay fungi and insects will take advantage of them and enter into them. This is one of the reasons severely pruning a tree's canopy is extremely harmful to it. I have attached a section of basic pruning guidelines on Pages 6 & 7 for your use when working with tree pruning personnel.

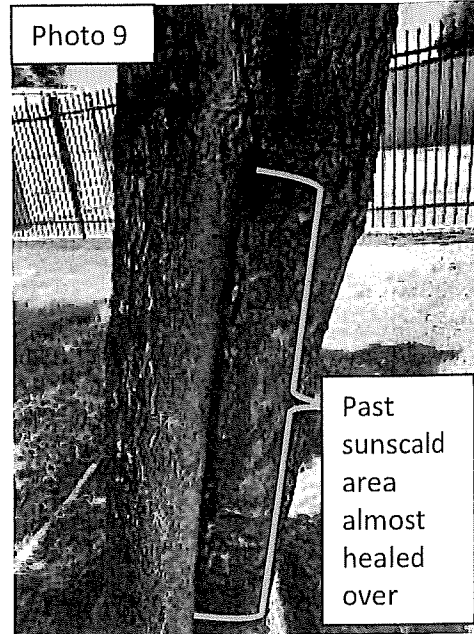
There was one more Ash tree that had sunscald on its trunk in the past and had wood decay and insects in it; see Photo 9 on Page 5. Its bark had since been shaded by its own branches and had grown back over much of the wounded area. The decay inside it was not dramatically affecting its health, but in the long term, it may compromise its structural integrity. The tree should be monitored annually. This tree was north/northeast of the library building toward the school where there were a container, temporary classrooms, and a basketball hoop.
